## 6970 47th Ave SW ~ Sewer Inspection

**Location**  
6970 47th Ave SW  
Seattle WA

3/19/2024

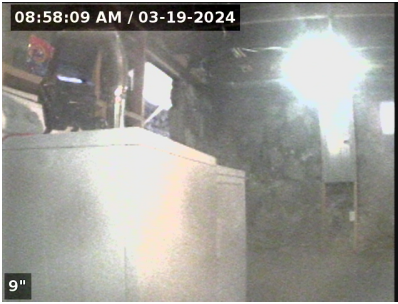
9"

Video out of the house is ready at: <https://youtube.com/watch?v=5UILLwszniOg>

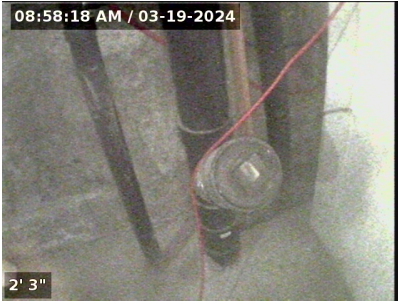
2' 3"

Access to the sewer line located in the basement

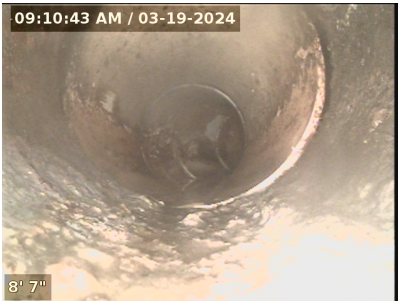
8' 7"

Cast iron pipe connects with PVC pipe as the sewer line exits out of the house

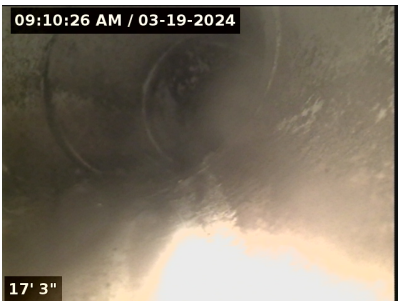
17' 3"

Pipe turns south off the property

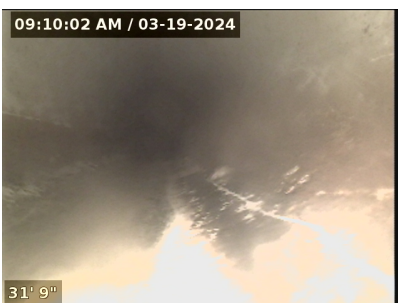
31' 8"

Updated PVC piped sewer line

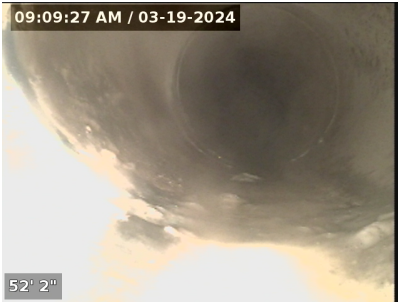
52' 2"

Connection into the shared line with three other properties to the south and the east

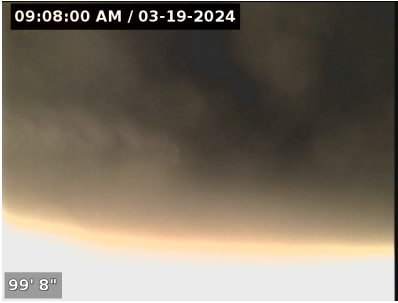
99' 8"

Standing water due to debris in the shared line

Have the line jetted to remove the debris and standing water from the line.

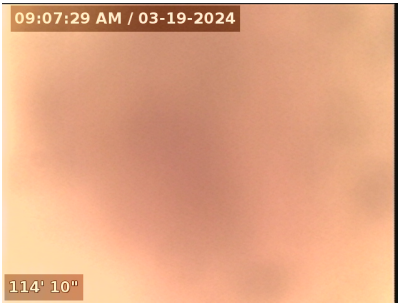
114' 11"

Debris in the line

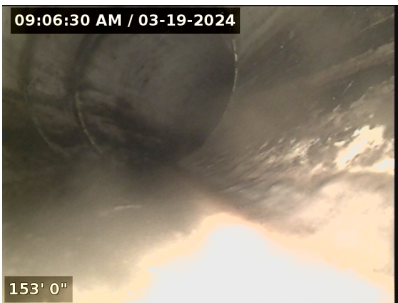
153' 0"

Pipe turns into the street

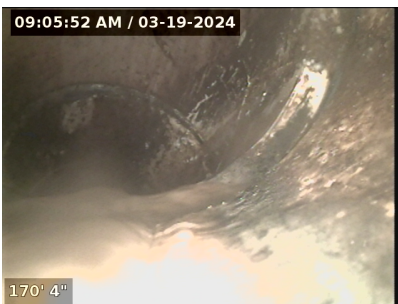
170' 4"

Video from the main city sewer line back to the house: <https://youtube.com/watch?v=HNYWy4UCjd4>
